**Flood Control Project Maintenance
Levee Inspections**

Maintenance Issue Types Only, Levee Inspection Report By Mile - Spring 2020

Reclamation District No. 0150 Merrit Island

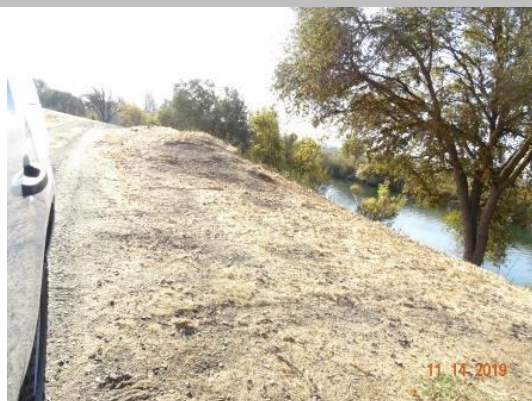
Photo 1 of 1 : SP_2020_RD0150_15_7_20200302_00002.jpg

View of fill material stored on the crown and shoulder. Fall 2019

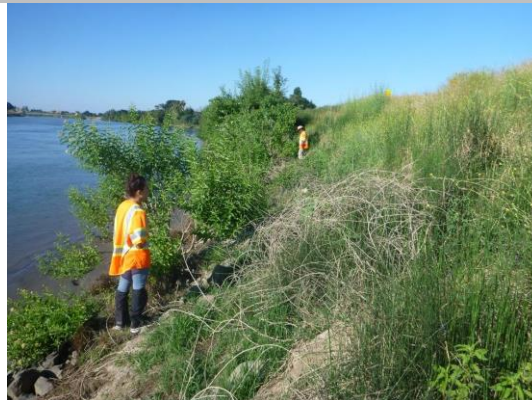
Photo 2 of 4 : LEVAL_SP_2020_286_1942.jpg

LM Start	0.11	Rating **	A/W	Issue No.	46
LM End	0.14	Issue Type +	Ma	Location *	WS
Category	Earthen Levee			GPS Latitude/Longitude	
				Start	End
Item	Erosion / Bank Caving			38.329369 °	38.329767 °
				-121.574936 °	-121.574589 °
DWR ID	LMA-112				
Comment Code					
E1 : Note and monitor erosion site.					
Inspector Comment					
Riprap on the upper slope of LM 0.14 near the private dock appears to be intact. The 2017 flood damage consists of a waterside erosion approximately 185 feet long on the west (right) bank of the Sacramento River. The crown is a paved road. Scarps are up to 3 ft deep but are not fully vertical. Monitor this stie, because the erosion is not very deep into prism. Site ID No:286 Site Designation:LMA-112

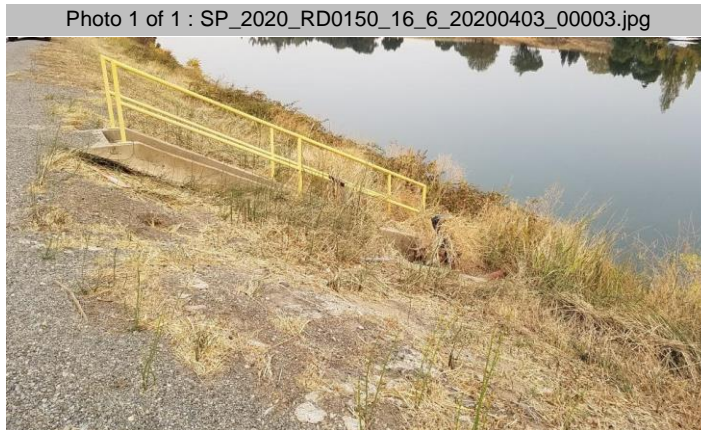
Photo 1 of 1 : SP_2020_RD0150_16_6_20200403_00003.jpg

LM Start	0.38	Rating **	M	Issue No.	6
LM End	0.38	Issue Type +	Ma	Location *	WS
Category	Earthen Levee			GPS Latitude/Longitude	
				Start	End
Item	Slope Stability			38.332598 °	38.332598 °
				-121.572179 °	-121.572179 °
DWR ID	DWR_RD0150_02_s_2012_6				
Comment Code					
S2 : Repair the levee slope damaged by foot traffic and prevent access where possible.					
Inspector Comment

View of slope instability around stairway. Fall 2018

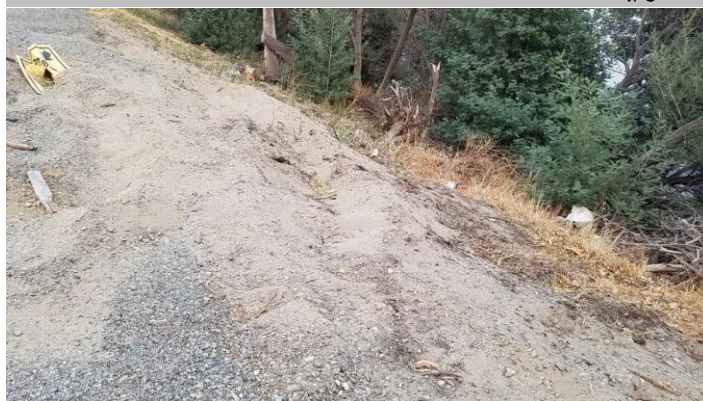
Photo 1 of 1 : SP_2020_RD0150_16_45_20200403_00015.jpg

LM Start	0.59	Rating **	M	Issue No.	45
LM End	0.59	Issue Type +	Ma	Location *	WS
Category	Earthen Levee			GPS Latitude/Longitude	
				Start	End
Item	Slope Stability			38.334898 °	38.334898 °
				-121.569632 °	-121.569632 °
DWR ID	DWR_RD0150_02_f_2018_45				
Comment Code					
S3 : Repair the levee slope damaged by vehicle traffic and prevent access where possible.					
Inspector Comment

View of slope damage likely from vehicle traffic. Fall 2018

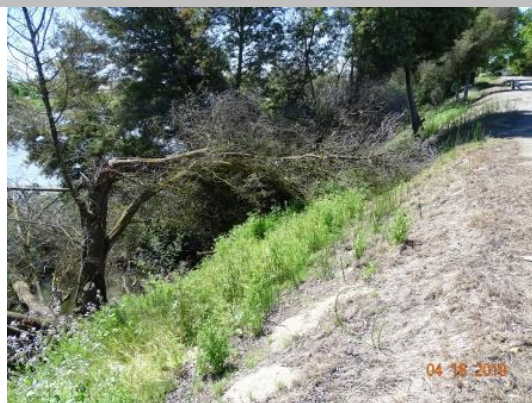
Photo 1 of 1 : SP_2020_RD0150_16_114_20200403_00059.jpg

View looking downstream at fallen tree on levee slope. Spring 2019

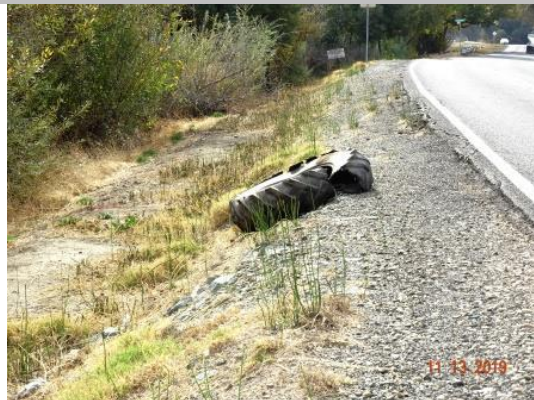
Photo 1 of 1 : SP_2020_RD0150_16_35_20200403_00011.jpg

View of tire on waterside slope. Fall 2019

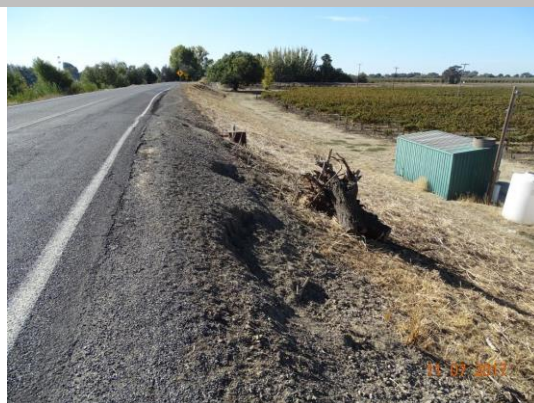
Photo 1 of 1 : SP_2020_RD0150_16_59_20200403_00039.jpg

LM Start	0.71	Rating **	U	Issue No.	59
LM End	0.71	Issue Type +	Ma	Location *	LS
Category	Earthen Levee			GPS Latitude/Longitude	
				Start	End
Item	Trim / Thin Trees			38.336291 °	38.336291 °
				-121.568260 °	-121.568260 °
DWR ID	DWR_RD0150_02_s_2016_59				
Comment Code					
T5 : Tree stumps.					
Inspector Comment					
Remove trees and repair slope damage.

View of the tree trunk on the landside of the levee. Fall 2017

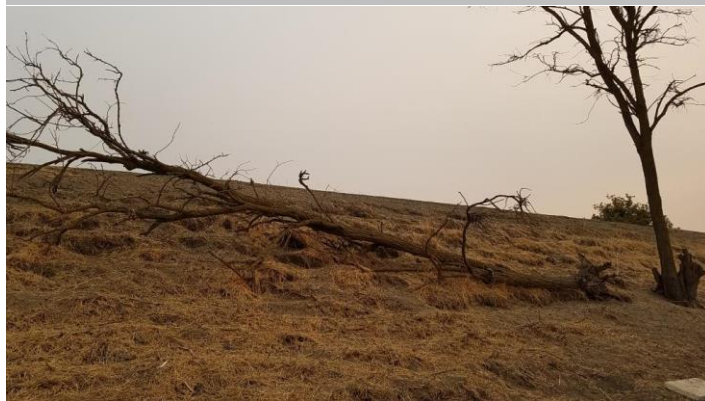
Photo 1 of 1 : SP_2020_RD0150_16_73_20200403_00045.jpg

View of fallen tree on landside levee slope. Fall 2018

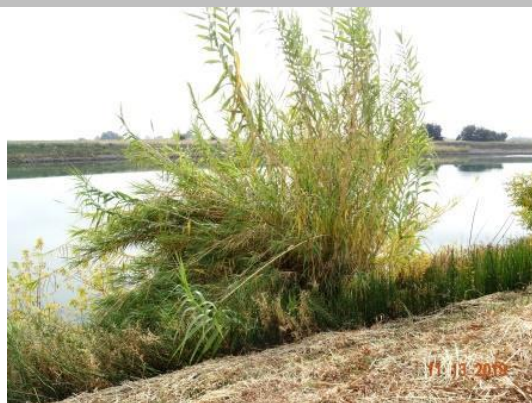
Photo 1 of 1 : SP_2020_RD0150_16_36_20200403_00012.jpg

View of Arundo growth. Fall 2019

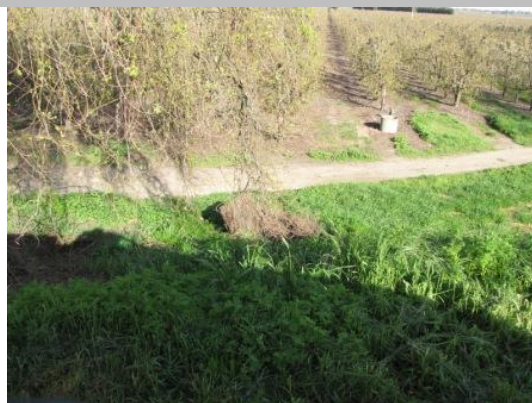
Photo 1 of 1 : SP_2020_RD0150_16_14_20200403_00006.jpg

View of a tree stump on the landward slope.

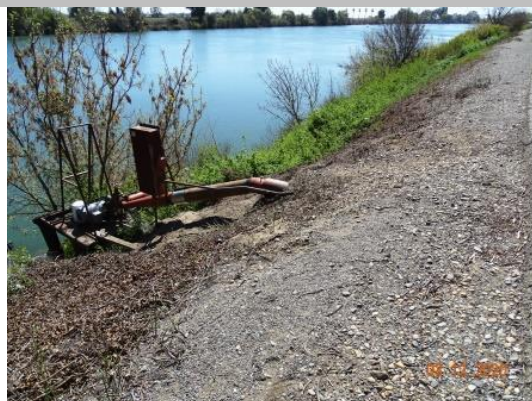
Photo 1 of 2 : SP_2020_RD0150_16_961_20200403_00061.jpg

LM Start	3.24	Rating **	M	Issue No.	961
LM End	3.24	Issue Type +	Ma	Location *	WS
Category	Earthen Levee			GPS Latitude/Longitude	
				Start	End
Item	Erosion / Bank Caving			38.355321 °	38.355321 °
				-121.530902 °	-121.530902 °
DWR ID	DWR_RD0150_02_s_2012_961				
Comment Code					
E2 : Schedule repair of erosion site prior to the next inspection.					
Inspector Comment					
Depressions into the waterward slope can be seen at this site. Also note the damaged pump support, pump, and pipe just upstream of the site.

View of erosion on the waterside slope around the pump. Spring 2020

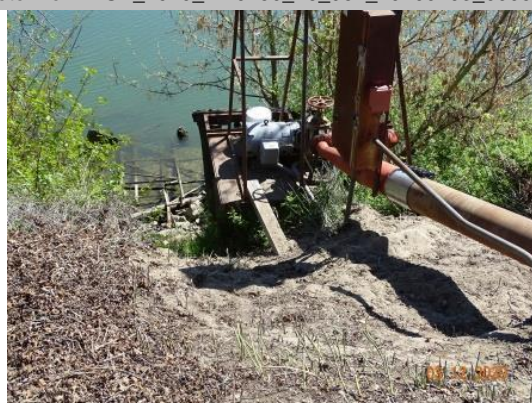
Photo 2 of 2 : SP_2020_RD0150_16_961_20200403_00062.jpg

View of erosion on the waterside slope around the pump. Spring 2020

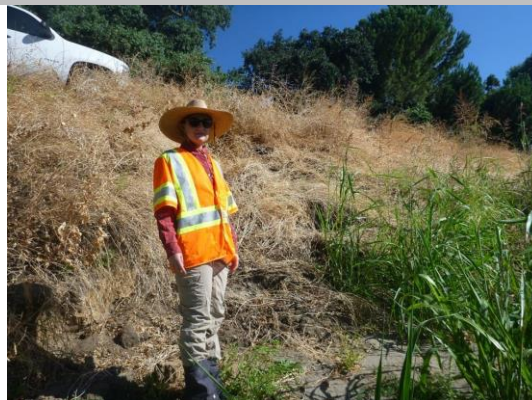
Photo 2 of 3 : LEVAL_SP_2020_287_2146.jpg

The flood damage consists of a waterside erosion approximately 229 feet long on the west (right) bank of the Sacramento River.

The crown is a paved road. There are erosion scarps up to 10 ft deep and within 5 ft of the crown. Worse conditions are on the DS end. There is exposed filter fabric. This erosion is serious, because of depth of erosion into the levee, weak soil, and proximity to the crown which is a high traffic public road. The slope appears to be intact to at least 5-10' from the levee shoulder.

Planned For Repair.

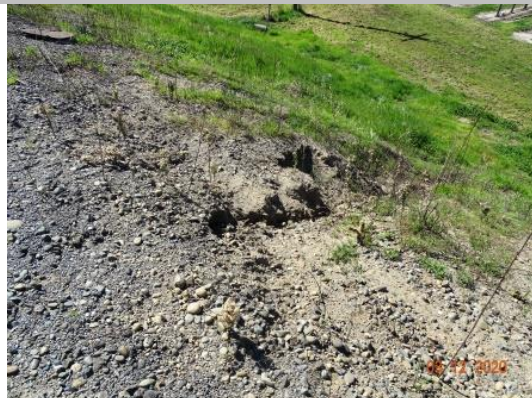
Photo 1 of 2 : SP_2020_RD0150_16_81_20200403_00050.jpg

LM Start	4.18	Rating **	M	Issue No.	81
LM End	4.18	Issue Type +	Ma	Location *	LS
Category	Earthen Levee			GPS Latitude/Longitude	
				Start	End
Item	Erosion / Bank Caving			38.366222 °	38.366222 °
				-121.522423 °	-121.522423 °
DWR ID	DWR_RD0150_02_s_2020_81				
Comment Code					
E2 : Schedule repair of erosion site prior to the next inspection.					
Inspector Comment

View of erosion on the landside slope due to runoff. Spring 2020

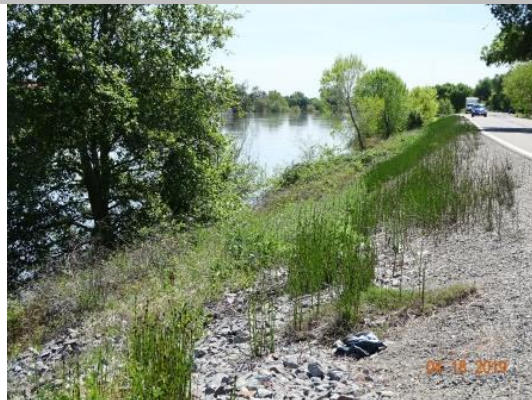
Photo 1 of 1 : SP_2020_RD0150_16_38_20200403_00013.jpg

LM Start	4.50	Rating **	U	Issue No.	38
LM End	4.57	Issue Type +	Ma	Location *	WS
Category	Supplemental			GPS Latitude/Longitude	
				Start	End
Item	2017 USACE Erosion Survey			38.370928 °	38.371909 °
				-121.523069 °	-121.523316 °
DWR ID	DWR_RD0150_02_s_2019_38				
Comment Code					
Inspector Comment					
2020 Spring DWR: Lower bank erosion is not visible from the crown.					
2017 Site ID: SAC 38.5 R					
Status: Critical					
2017 Field Notes: New erosion pocket. Vertical section along lower bank, and cracking. Upgraded to critical.					
Site History: 1999 - Downstream end (300 ft) repaired with rock. 2010 - Toe erosion, some vertical slopes lower down. 2011 - Failing rock repair. Slumping of the lower bank. Minor new erosion. 2013 - Tree at upstream end has exposed roots. Some new erosion.

View looking downstream at 2017 USACE Erosion Survey site. Spring 2019

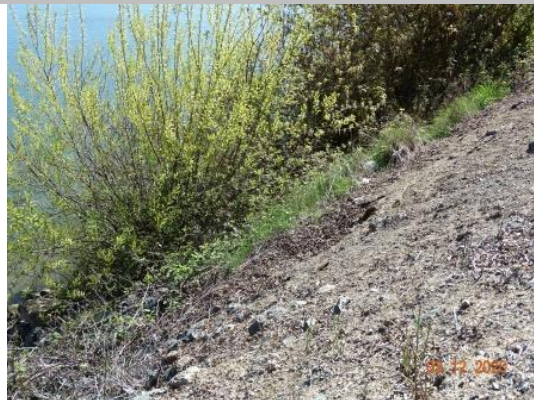
Photo 1 of 3 : SP_2020_RD0150_16_50_20200403_00025.jpg

There is some bank caving near the trees. The flood damage consists of a waterside erosion approximately 447 feet long on the west (right) bank of the Sacramento River.

View of bank caving on the lower slope. Spring 2020

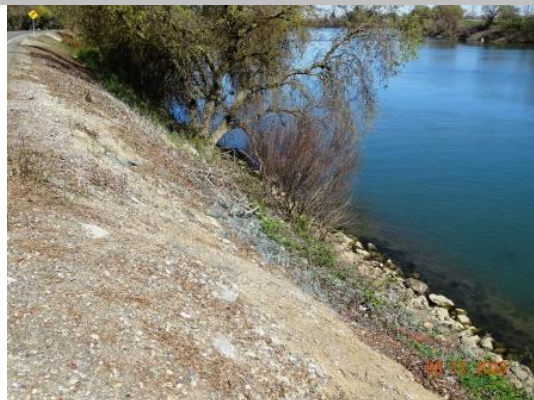
Photo 2 of 3 : SP_2020_RD0150_16_50_20200403_00026.jpg

View of riprap on the lower slope. Spring 2020

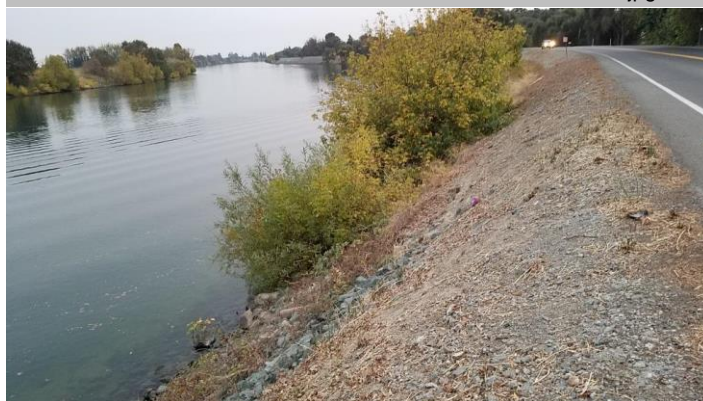
Photo 3 of 3 : SP_2020_RD0150_16_50_20200403_00027.jpg

View of waterside slope with some revetment. Fall 2018

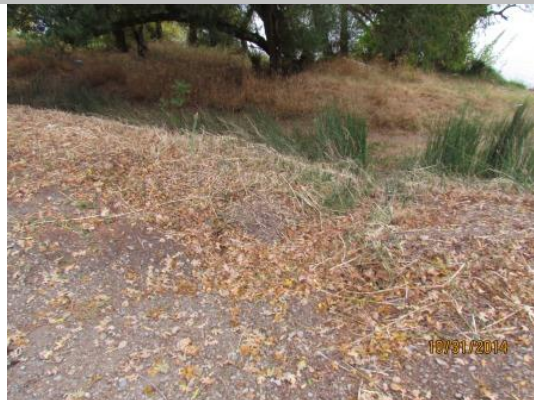
Photo 1 of 1 : SP_2020_RD0150_16_54_20200403_00035.jpg

LM Start	5.33	Rating **	M	Issue No.	54
LM End	5.33	Issue Type +	Ma	Location *	WS
Category	Earthen Levee			GPS Latitude/Longitude	
				Start	End
Item	Slope Stability			38.382072 °	38.382072 °
				-121.523220 °	-121.523220 °
DWR ID	DWR_RD0150_02_f_2014_54				
Comment Code					
S2 : Repair the levee slope damaged by foot traffic and prevent access where possible.					
Inspector Comment

View of slope instability on the waterside of the levee looking towards the toe. Fall 2014

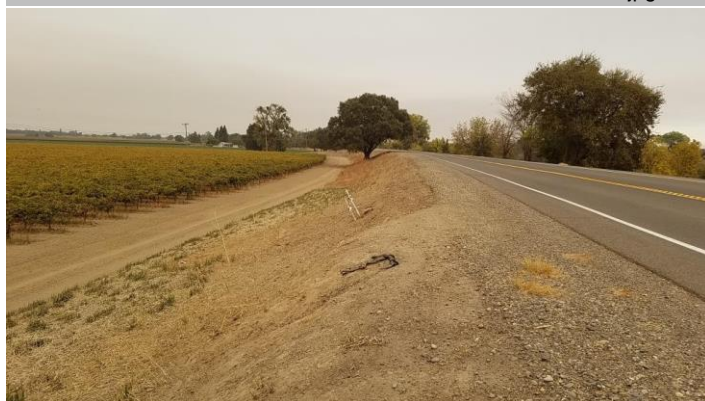
Photo 1 of 2 : SP_2020_RD0150_16_52_20200403_00028.jpg

LM Start	5.90	Rating **	M	Issue No.	52
LM End	5.90	Issue Type +	Ma	Location *	LS
Category	Earthen Levee			GPS Latitude/Longitude	
				Start	End
Item	Erosion / Bank Caving			38.387915 °	38.387915 °
				-121.516002 °	-121.516002 °
DWR ID	DWR_RD0150_02_f_2016_52				
Comment Code					
E2 : Schedule repair of erosion site prior to the next inspection.					
Inspector Comment					
Repair erosion due to runoff.

View of erosion due to runoff. Fall 2018

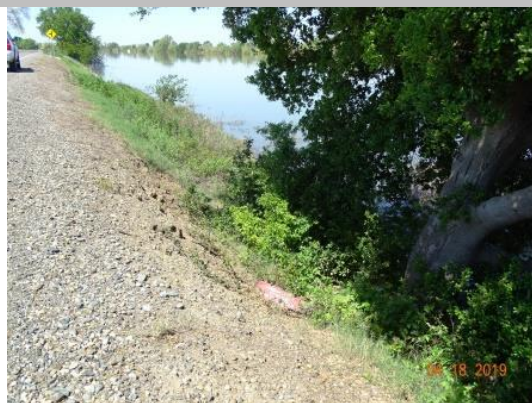
Photo 1 of 5 : SP_2020_RD0150_16_53_20200403_00030.jpg

View looking upstream at erosion around tree. Spring 2019

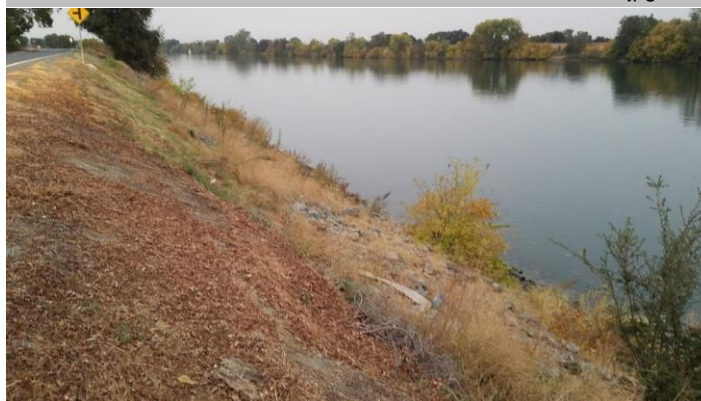
Photo 2 of 5 : SP_2020_RD0150_16_53_20200403_00031.jpg

View of waterside slope with some revetment. Fall 2018

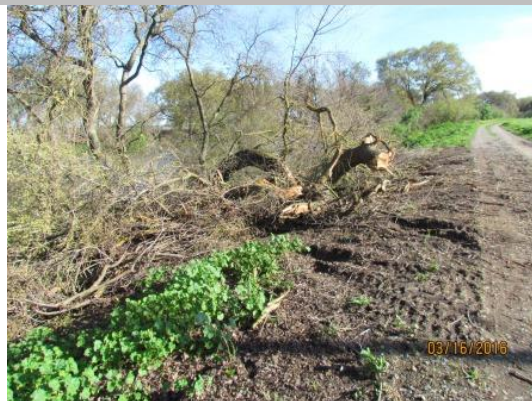
Photo 1 of 1 : SP_2020_RD0150_17_85_20200302_00055.jpg

View of broken tree trunk on the waterside slope of the levee. Spring 2016

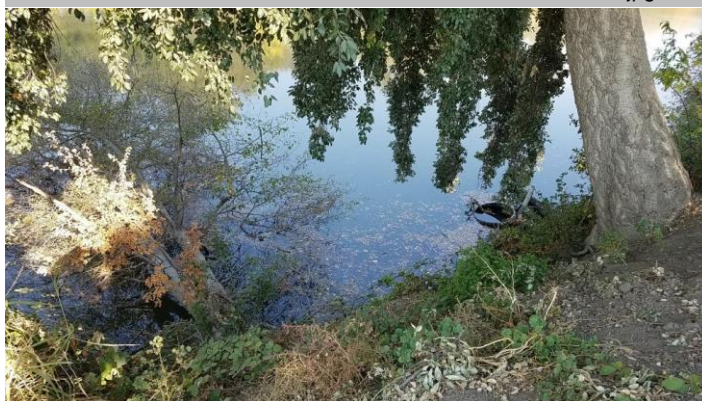
Photo 1 of 2 : SP_2020_RD0150_17_37_20200302_00013.jpg

View of slope damage near fallen tree. Fall 2018

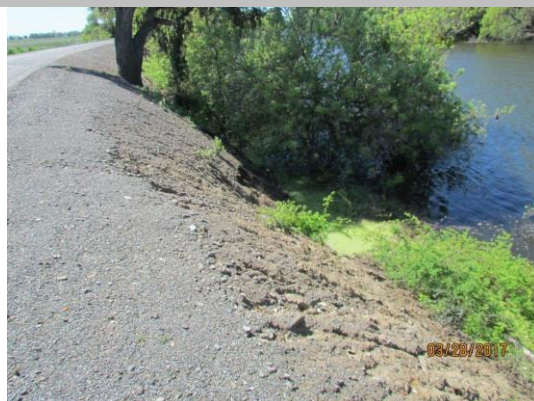
Photo 1 of 1 : SP_2020_RD0150_17_62_20200302_00039.jpg

View of erosion on the waterside slope of the levee looking downstream. Spring 2017

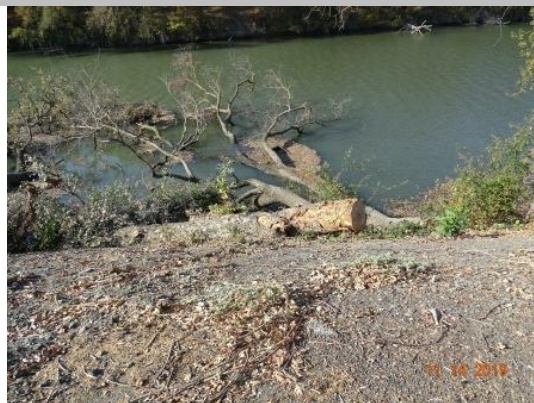
Photo 1 of 1 : SP_2020_RD0150_17_25_20200302_00006.jpg

View of a downed tree on the WS slope.

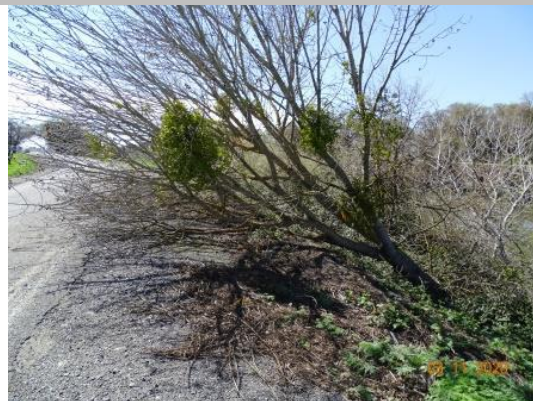
Photo 1 of 1 : SP_2020_RD0150_17_112_20200313_00149.jpg

View of a fallen tree leaning on the waterside slope. Spring 2020

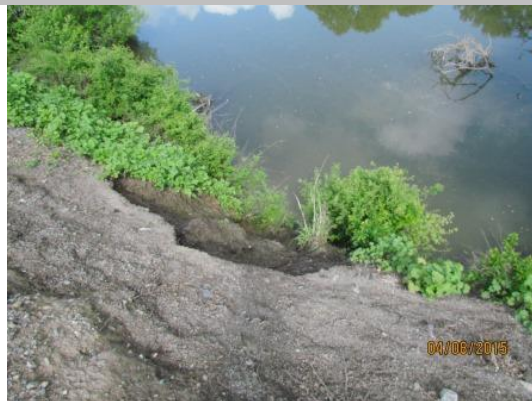
Photo 1 of 2 : SP_2020_RD0150_17_40_20200302_00018.jpg

View of erosion on the waterside of the levee during spring 2015 inspection.

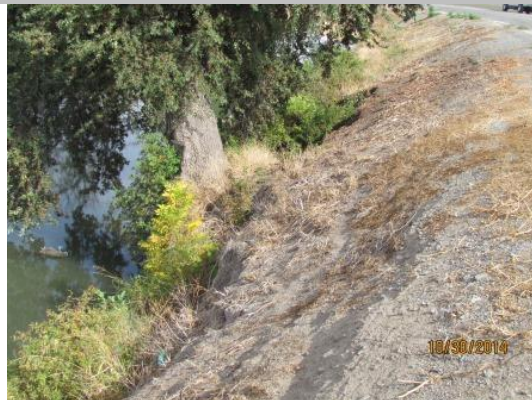
Photo 2 of 2 : SP_2020_RD0150_17_40_20200302_00019.jpg

View of erosion on the waterside of the levee looking upstream during fall 2014 inspection.

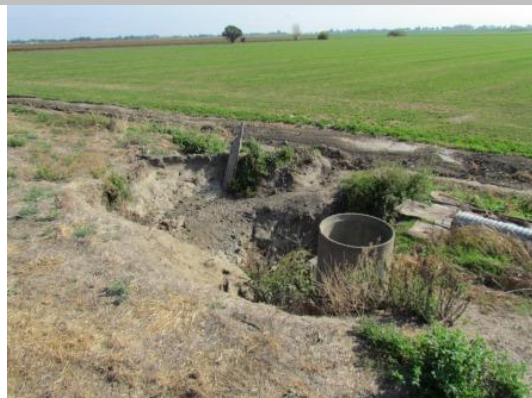
Photo 2 of 2 : SP_2020_RD0150_17_115_20200302_00081.jpg

A drainage ditch with depth of 4 feet and width of 15 feet was found on the landside toe of the levee. The picture was taken from the landside slope looking upstream during the fall 2013 inspection.

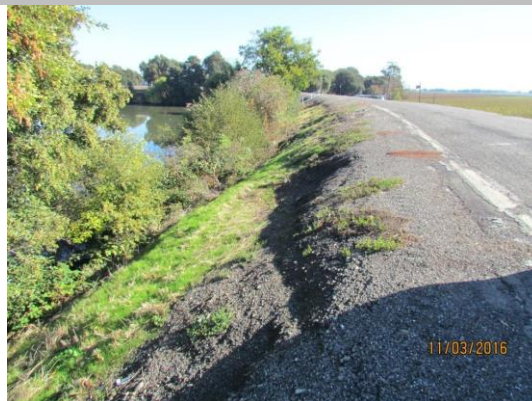
Photo 1 of 1 : SP_2020_RD0150_17_116_20200302_00082.jpg

View of slope instability on the waterside of the levee. Fall 2016

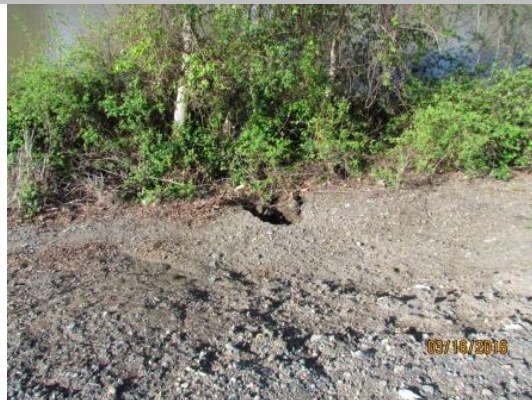
Photo 1 of 1 : SP_2020_RD0150_17_93_20200302_00062.jpg

Erosion was found on the waterside toe of the levee. Spring 2016

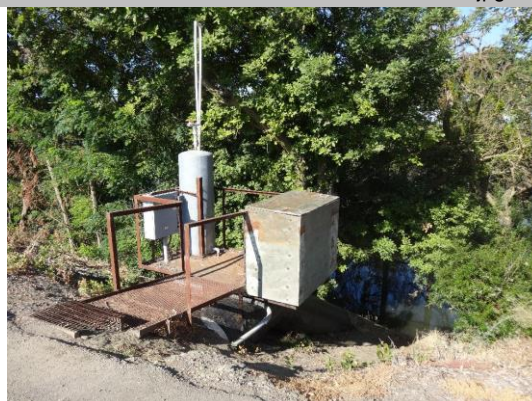
Photo 1 of 3 : UCIP_SP_2020_49386_63902.jpg

WS view: pipe, steel deck, pressure tank, electric control box on stream bank.

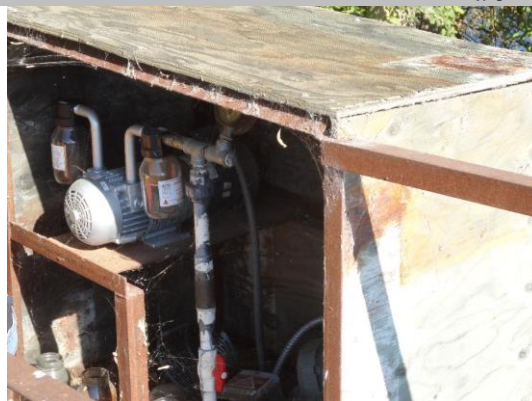
Photo 2 of 3 : UCIP_SP_2020_49386_63901.jpg

WS view: a smaller pump on steel deck. It was working during the survey.

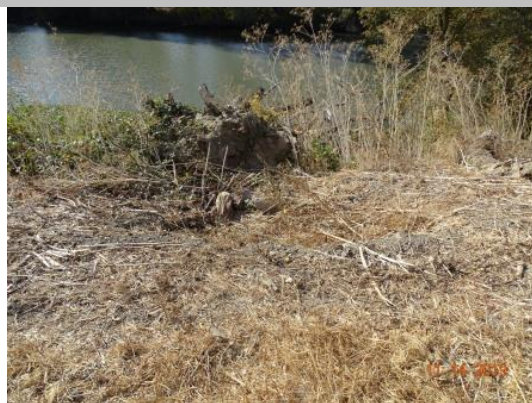
Photo 1 of 1 : SP_2020_RD0150_17_125_20200302_00093.jpg

LM Start	5.19	Rating **	M	Issue No.	125
LM End	5.19	Issue Type +	Ma	Location *	WS
Category	Earthen Levee			GPS Latitude/Longitude	
				Start	End
Item	Encroachments			38.381352 °	38.381352 °
				-121.540797 °	-121.540797 °
DWR ID	DWR_RD0150_03_s_2018_125				
Comment Code					
TR : Tree or limb					
Inspector Comment					
Remove a fallen tree with exposed rootball.

View of fallen tree with exposed rootball. Fall 2019

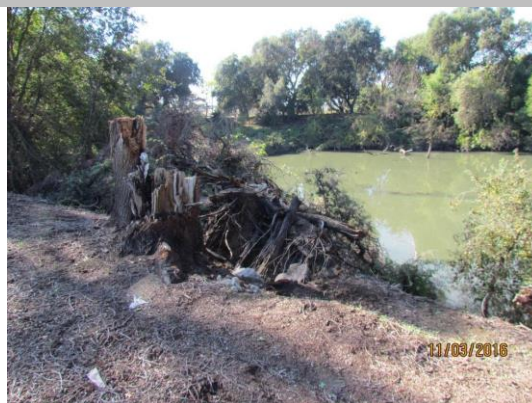
Photo 1 of 1 : SP_2020_RD0150_17_74_20200302_00047.jpg

View of stump and downed tree on the waterside slope of the levee.

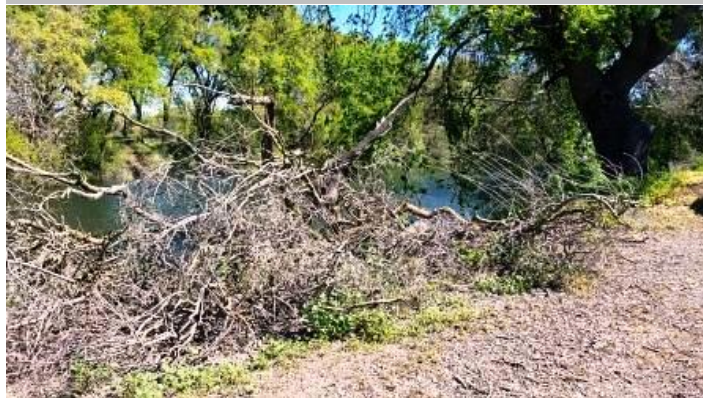
Photo 2 of 2 : SP_2020_RD0150_17_150_20200302_00097.jpg

View of tree debris on waterside slope. Spring 2019

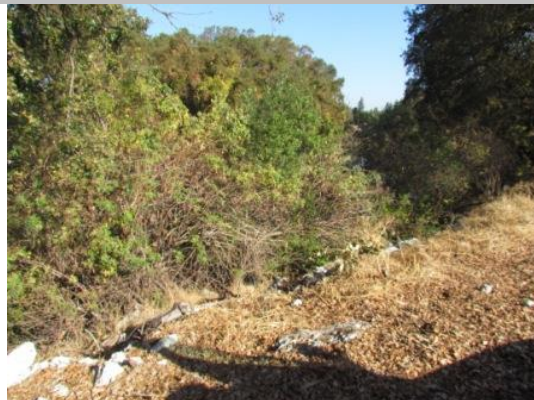
Photo 1 of 1 : SP_2020_RD0150_17_28_20200302_00008.jpg

Wild growth was found on the waterside slope of the levee looking upstream.

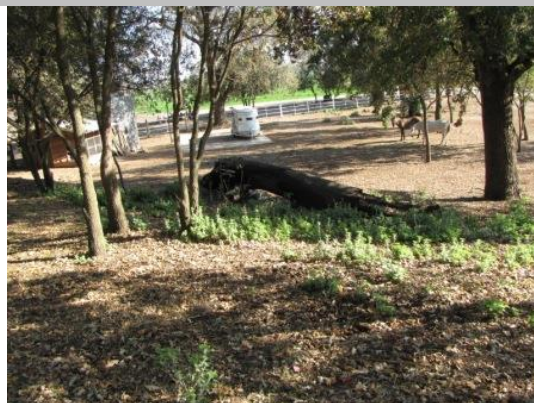
Photo 1 of 1 : SP_2020_RD0150_17_57_20200302_00033.jpg

View of downed tree on landward slope should be removed.

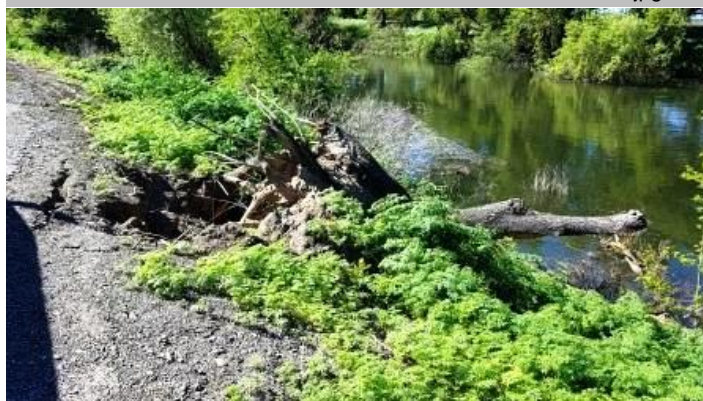
Photo 1 of 1 : SP_2020_RD0150_17_137_20200302_00095.jpg

View of fallen tree on waterside slope. Spring 2019

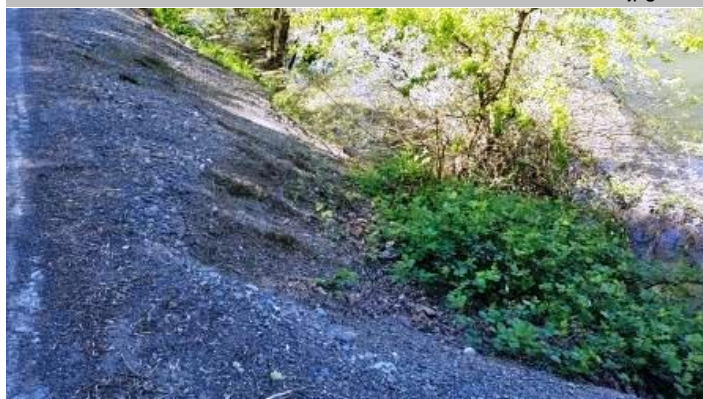
Photo 1 of 2 : SP_2020_RD0150_17_61_20200302_00037.jpg

View of erosion on waterside slope. Spring 2019

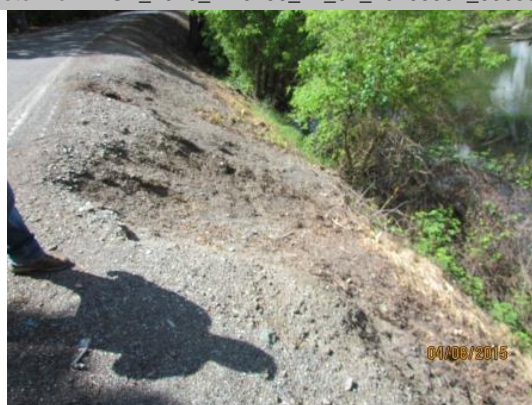
Photo 2 of 2 : SP_2020_RD0150_17_61_20200302_00038.jpg

View of erosion on the waterside of the levee during spring 2015 inspection.

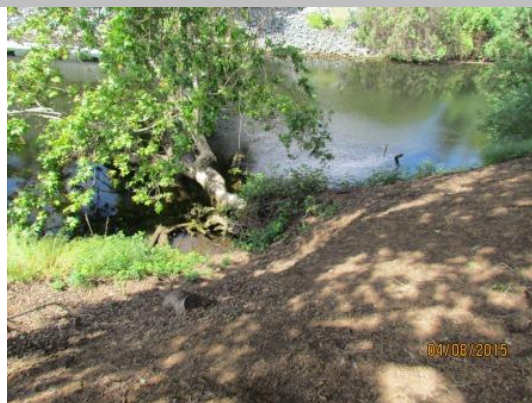
Photo 1 of 1 : SP_2020_RD0150_17_396_20200302_00098.jpg

Slope instability was found on the waterside toe of the levee looking upstream. Spring 2015

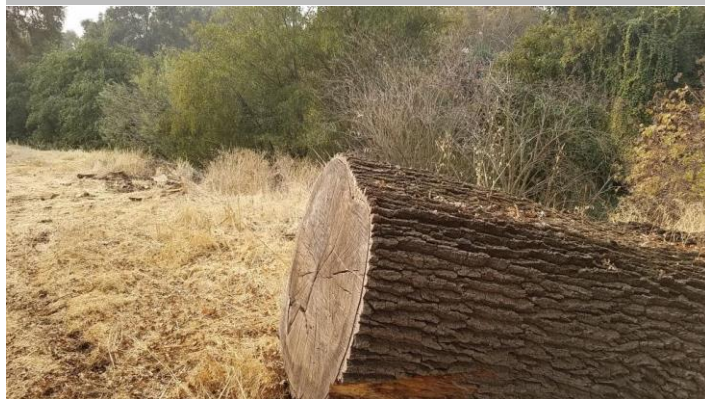
Photo 1 of 1 : SP_2020_RD0150_17_75_20200302_00048.jpg

View of downed tree on levee slope.

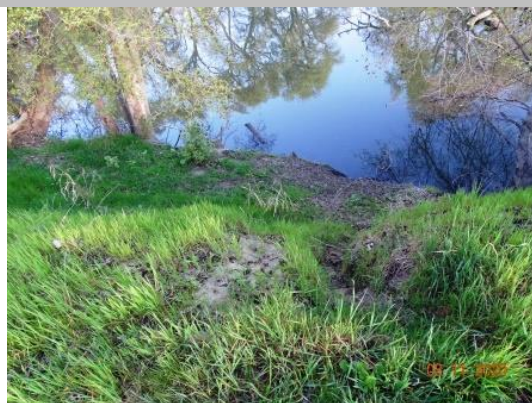
Photo 1 of 2 : SP_2020_RD0150_17_92_20200313_00146.jpg

View of slope instability on the waterside slope. Spring 2020

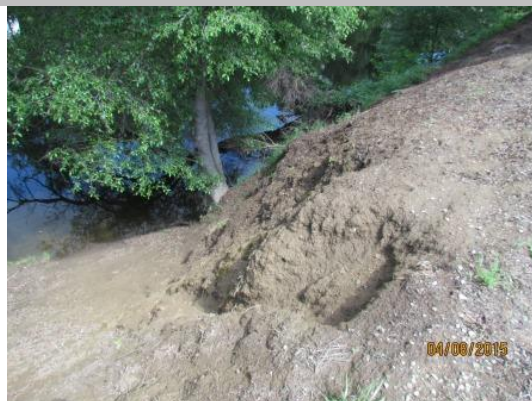
Photo 2 of 2 : SP_2020_RD0150_17_92_20200302_00060.jpg

View of slope instability on the waterside of the levee looking upstream during spring 2015 inspection.

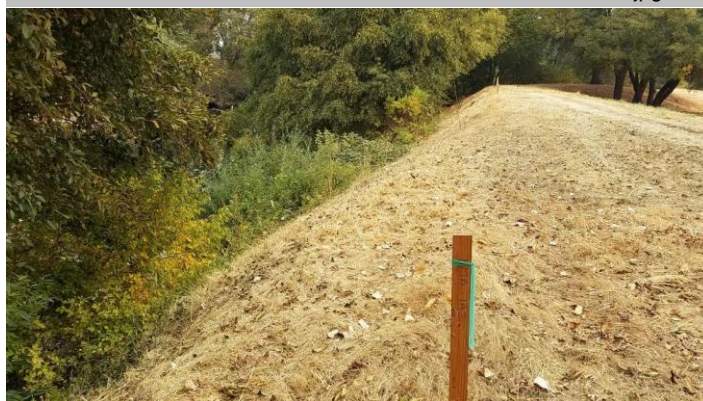
Photo 1 of 4 : SP_2020_RD0150_17_122_20200302_00086.jpg

View of waterside slope. Fall 2018

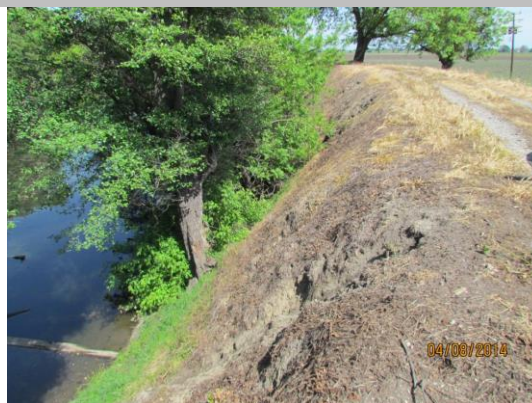
Photo 1 of 2 : SP_2020_RD0150_17_67_20200302_00044.jpg

View of the erosion on the waterside shoulder looking upstream. Spring 2014

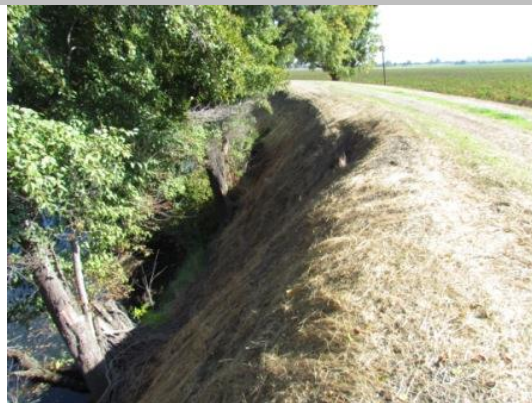
Photo 2 of 2 : SP_2020_RD0150_17_67_20200302_00045.jpg

Erosion was found on the waterside shoulder of the levee looking upstream. This picture was taken during fall 2012 inspection.

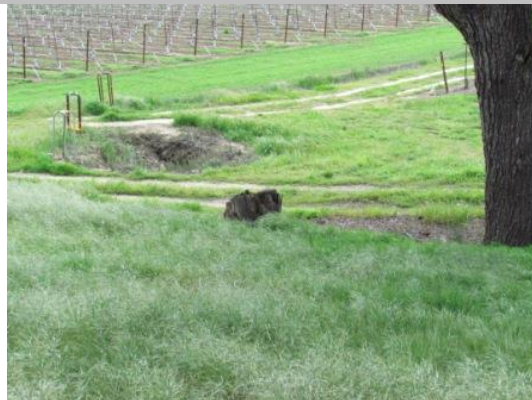
Photo 1 of 1 : SP_2020_RD0150_17_90_20200302_00056.jpg

A tree stump was found on the landside of the levee looking upstream.

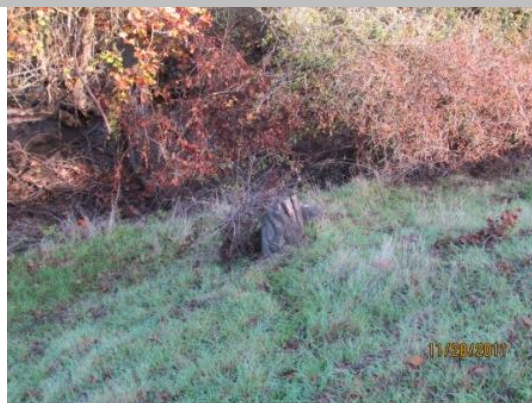
Photo 1 of 1 : SP_2020_RD0150_17_59_20200302_00035.jpg

A tree stump was found on the waterside of the levee looking upstream.
Fall 2011
